PHASE 1 REPORT

INFILTRATION & INFLOW
STUDY
TOWN OF CENTREVILLE

Prepared for:
Town of Centreville
Centreville, MD

April 2005

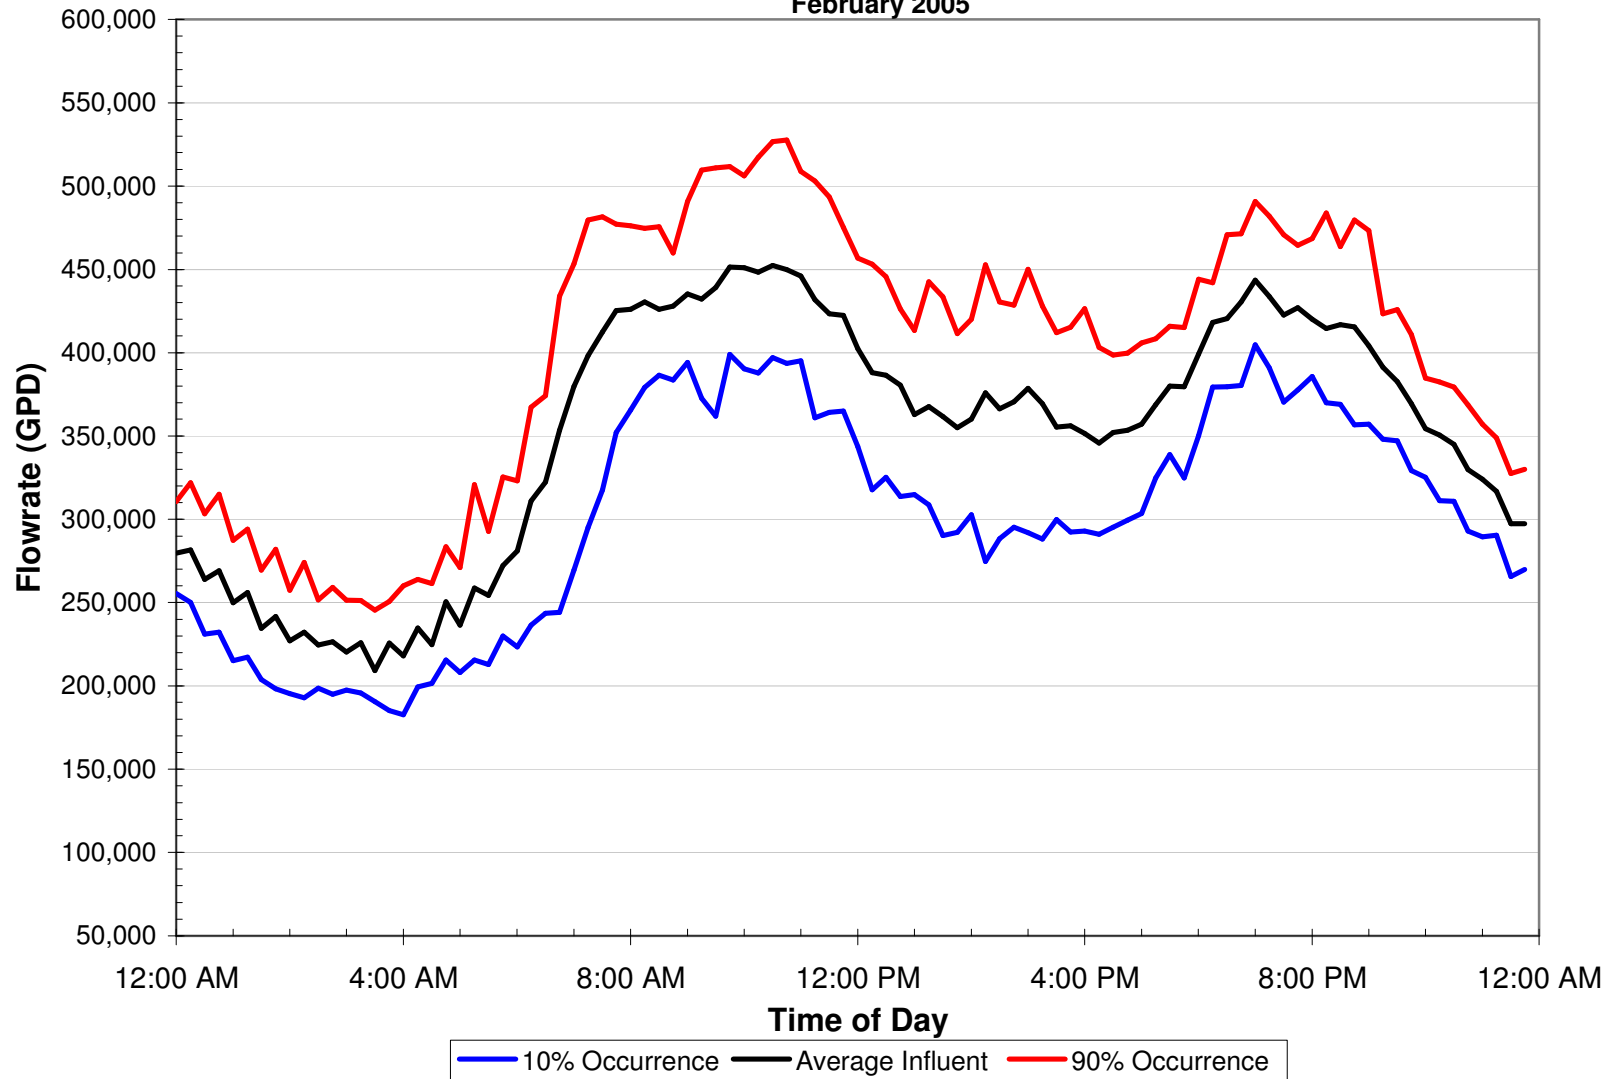
Figure 1
Centreville WWTP
Daily Influent Flow Trends
February 2005

URS reviewed WWTP flow data measured by the new influent meter at the WWTP for the month of February, 2005. The new meter records data in high resolution 15 minute intervals. A graph has been generated to depict the typical flow patterns into the WWTP throughout the day and is displayed as Figure 1. The typical flow patterns display the diurnal influent flow characteristic throughout the day. As you will note, the system has two peak flow times each day that occur during late morning and early evening. The peak conditions correspond with heavier usage during the morning and dinner time. You will also note that during the early morning hours, the flow never approaches zero as would be anticipated in a water tight system since water use/disposal should be relatively small at that time of the day. The fact that the Town continues to see an influent flow of approximately 225,000 gpd at that time indicates a steady source of extraneous flow indicative of infiltration of groundwater. The influent flow meter records also validate the measured dry weather weir data conducted in the middle of the night that is displayed later in this report.

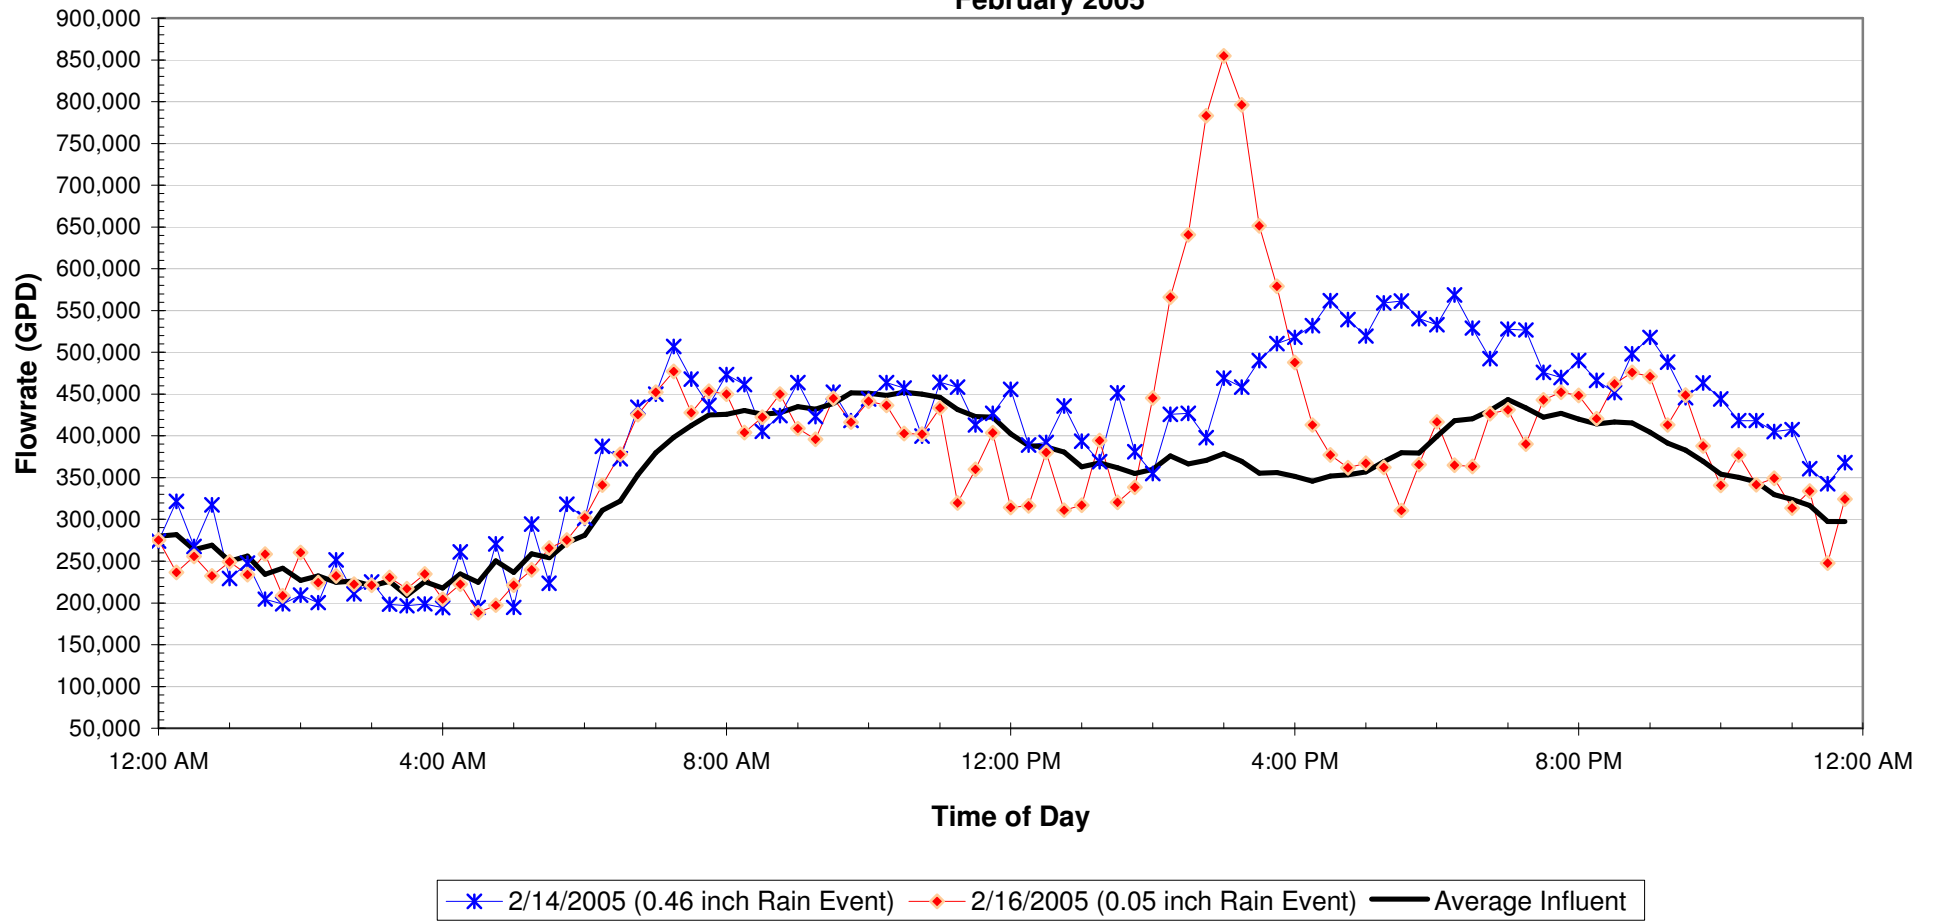
Figure 2
Centreville WWTP Influent Data (Rain Examples)
February 2005

The influent WWTP flow meter also indicates inflow spikes during rain events. The second graph (Figure 2) illustrates two rain event periods and the resulting impact on flow into the WWTP. As you will note, there are visible increases in flow to the WWTP when compared with the typical average flow pattern at the WWTP. This is indicative of inflow and rain induced infiltration entering the collection system. The magnitude and intensity of the rain events will proportionally cause increases in extraneous sources of inflow into the WWTP.

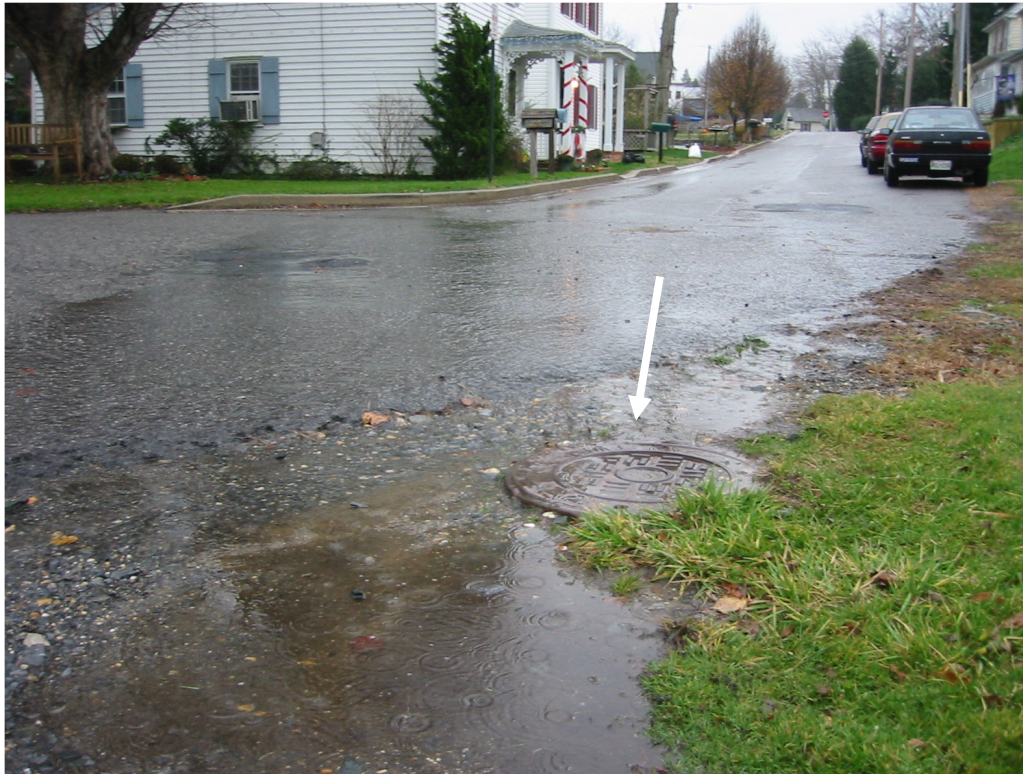
The following pictures illustrate P-1 manholes that are sources of Inflow during rain events. Refer to the attached Base Map to reference the locations of the Basins identified.

Surface runoff flowing into manhole.

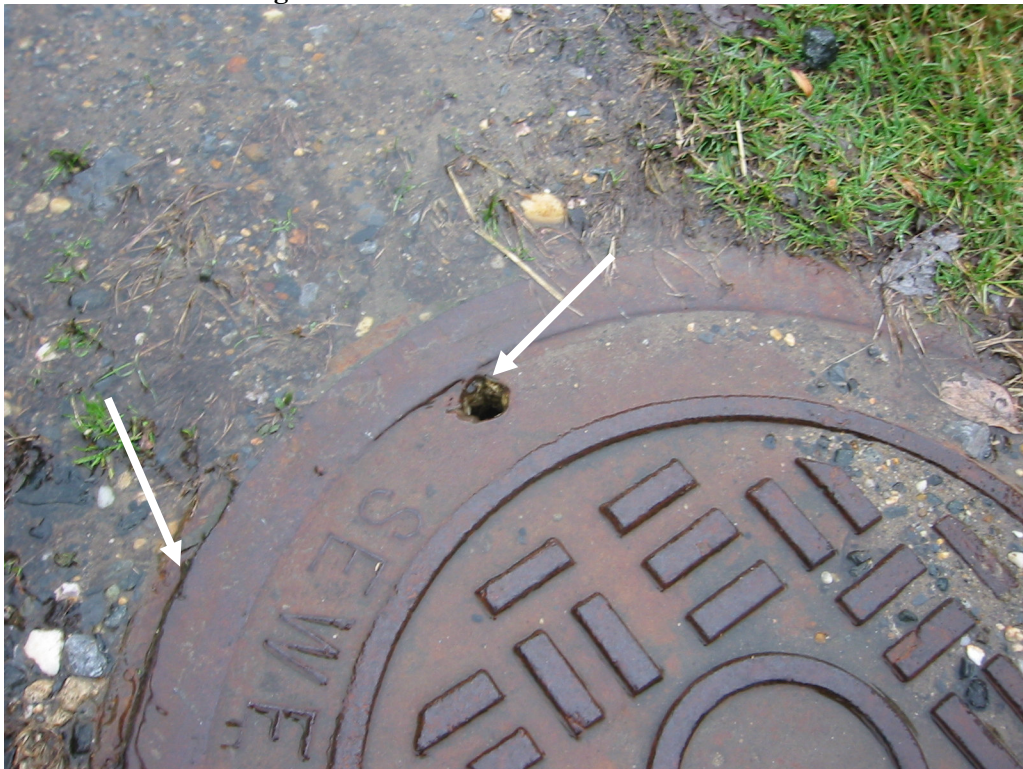
Close-up view of surface runoff entering manhole cover through the frame and pick hole.

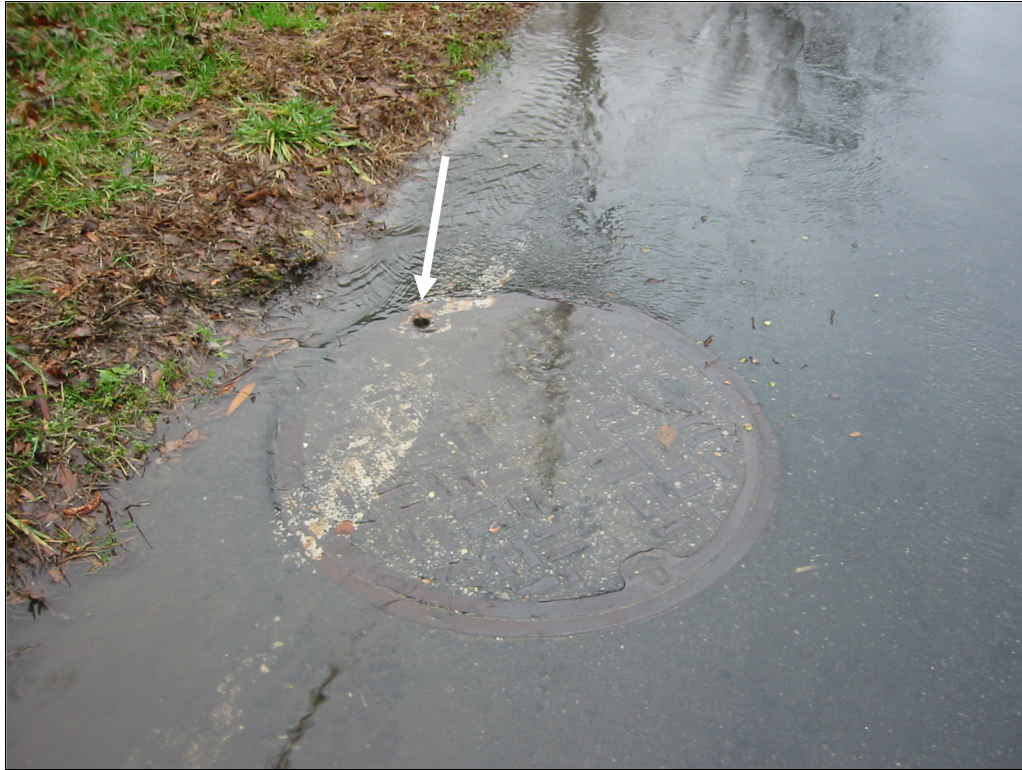
Surface runoff flowing over and into manhole lid.

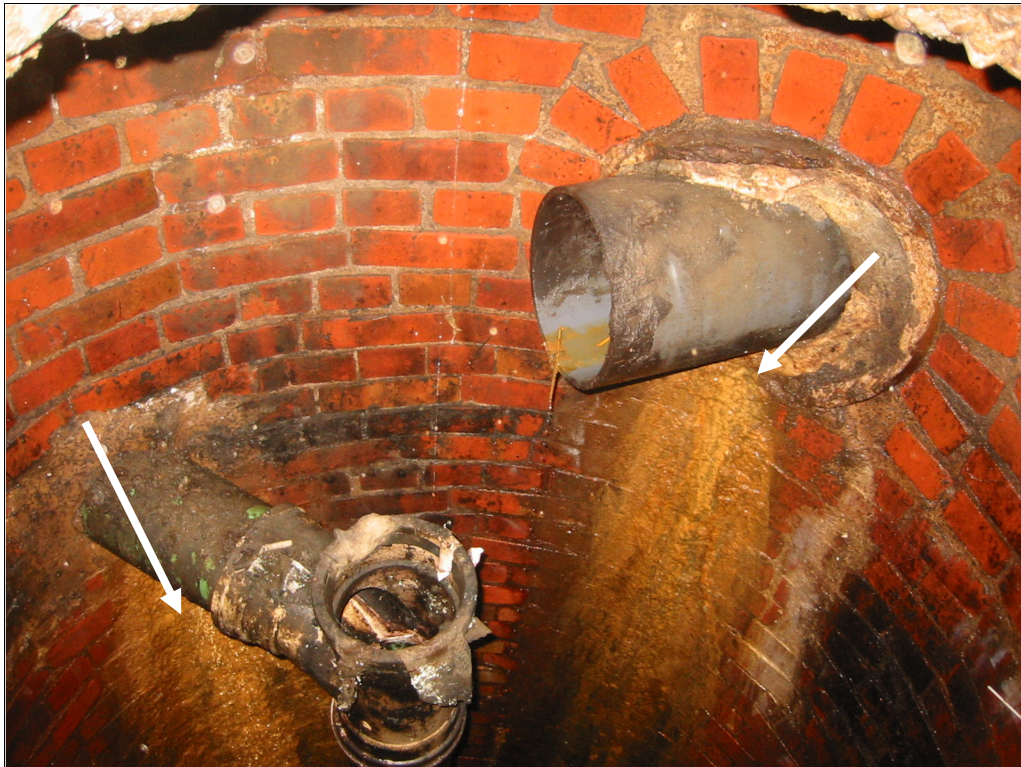
Leaking pipe penetrations in manhole. Rust colored deposits below pipes are mineral deposits indicative of groundwater. The pipes are only 2-4 feet below grade, indicating a shallow water table.

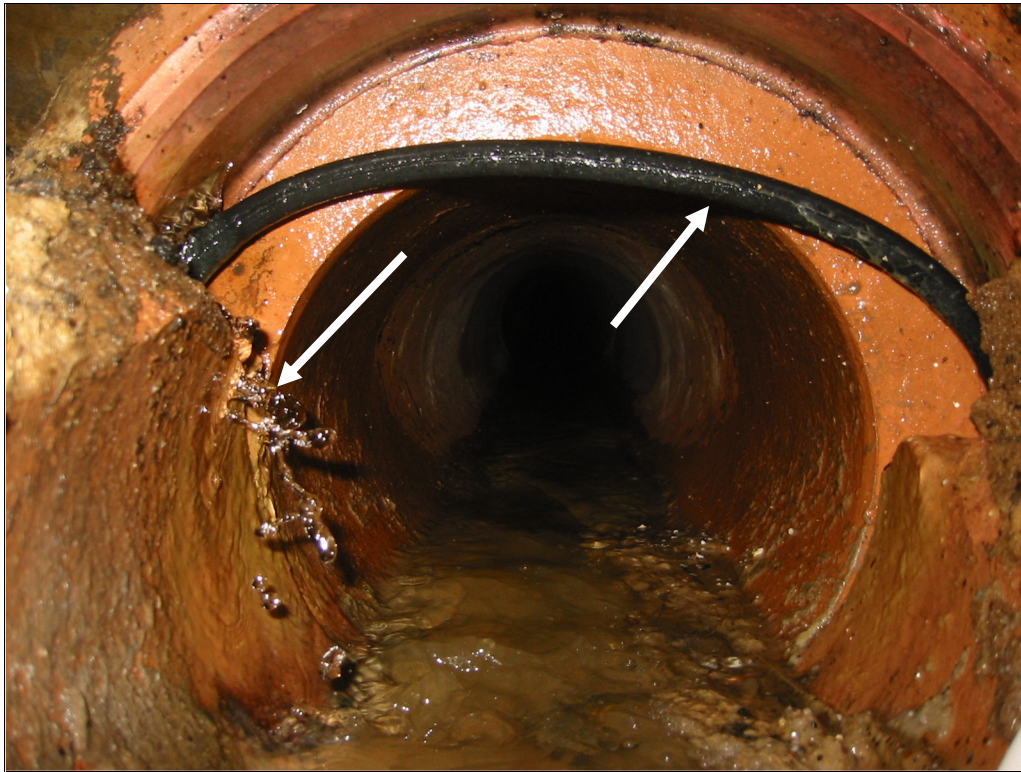
Leak from a poor seal between a pipe and manhole channel. The black gasket indicates relatively newer clay pipe.

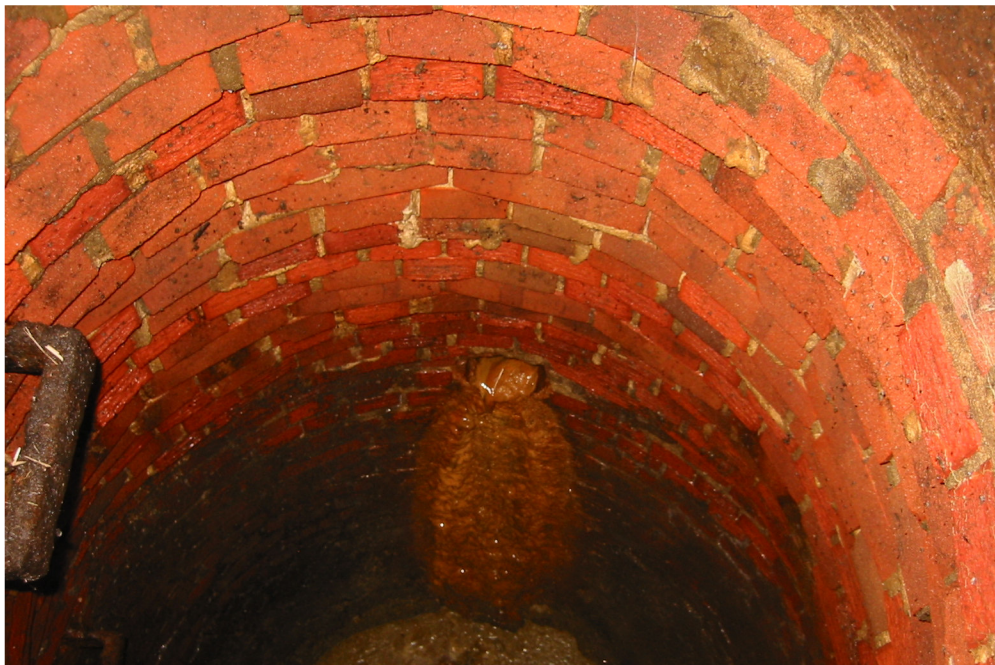
Pipe leaking groundwater into MH 102. Rust colored deposits below pipe are mineral deposits indicative of groundwater. Possibly an abandoned connection.
